Lanoguard Protection for Front-End Loaders

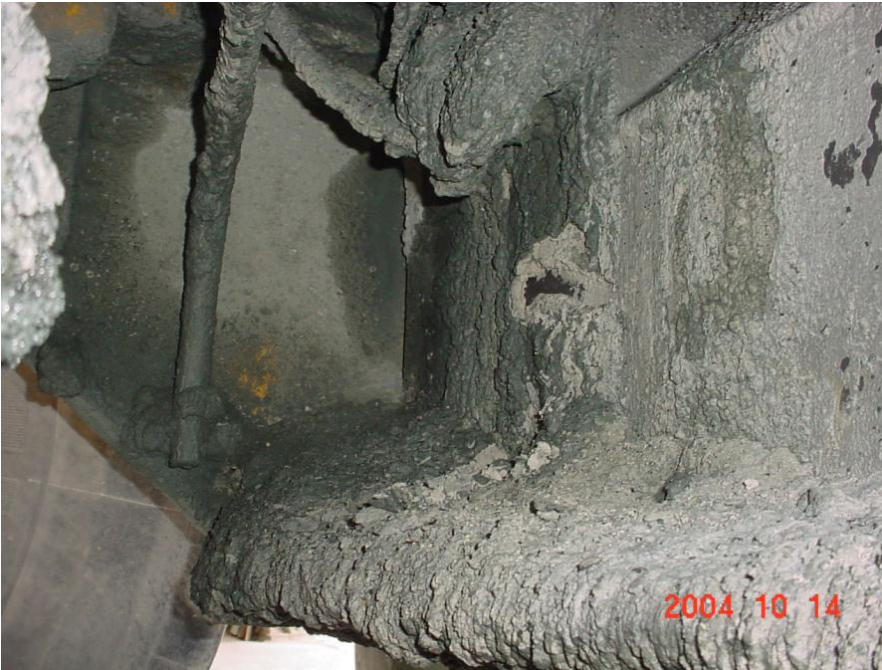
Figure 1: Under loader after 6 years not treated

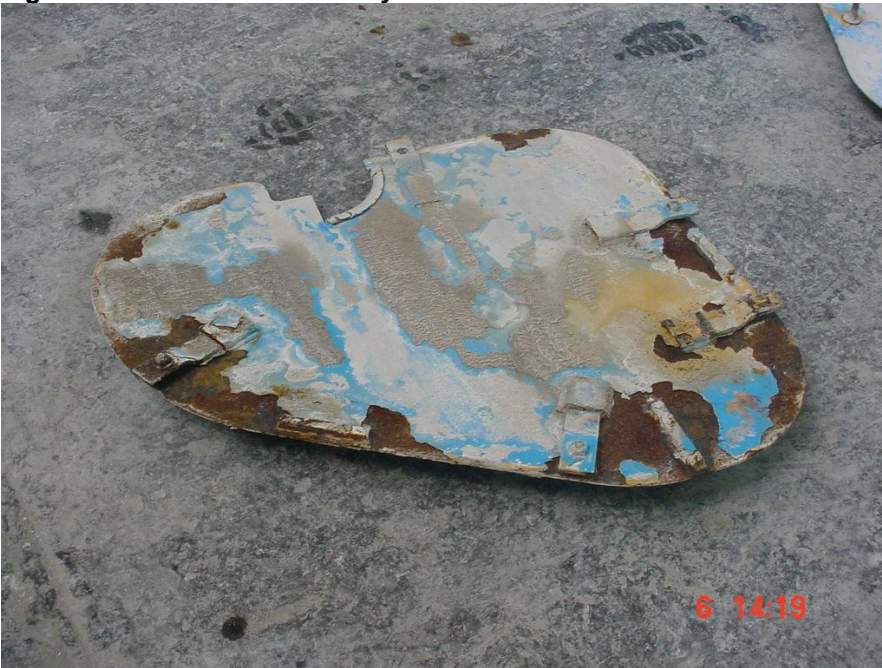
Figure 2: Side panel off loader after 6 year untreated

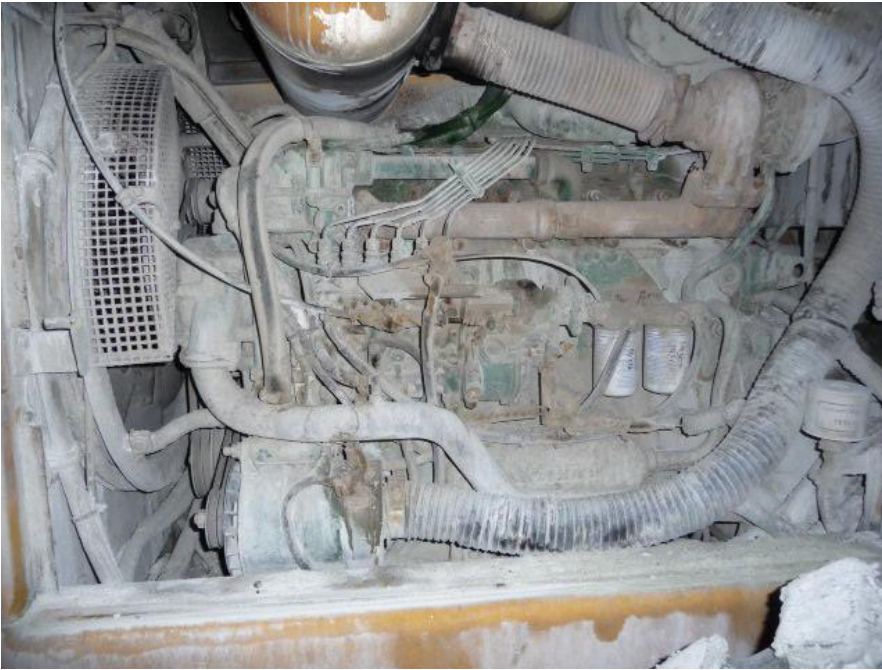
Figure 3: Engine bay after 6 years untreated (compare with Figure 11)

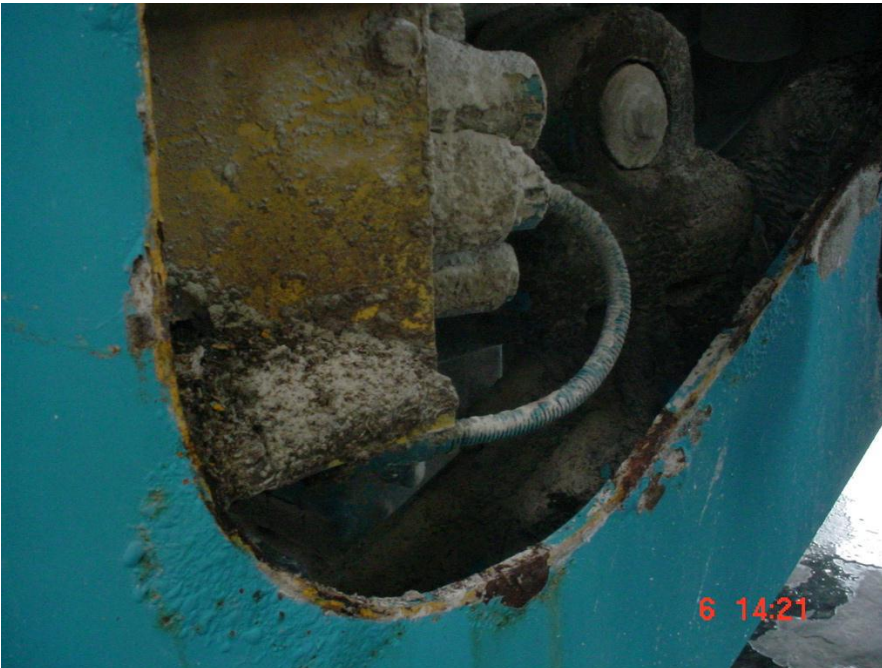
Figure 4: side of loader 6 years untreated (compare with Figure 10)

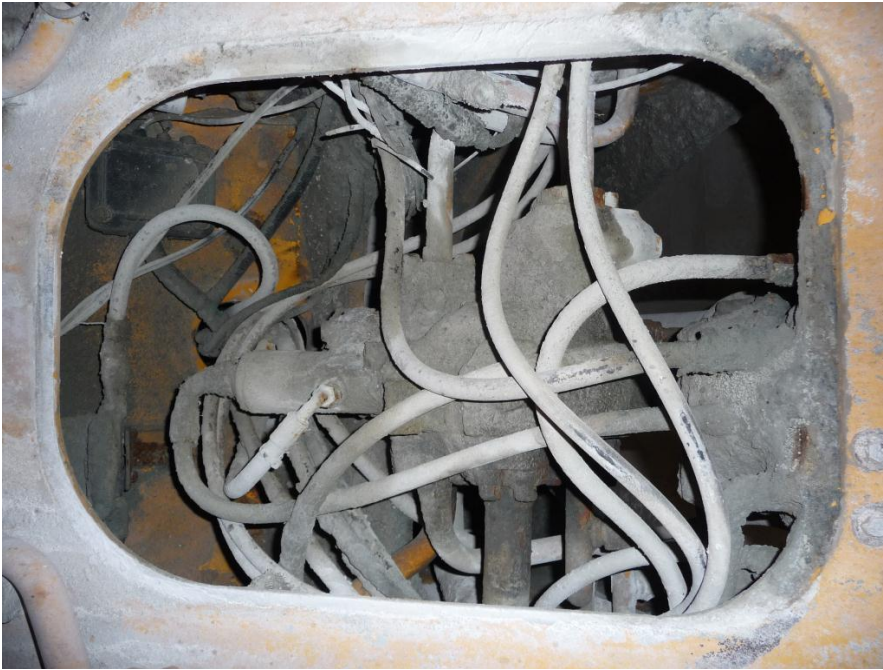
Figure 5: front hydraulic compartment untreated after 6 years

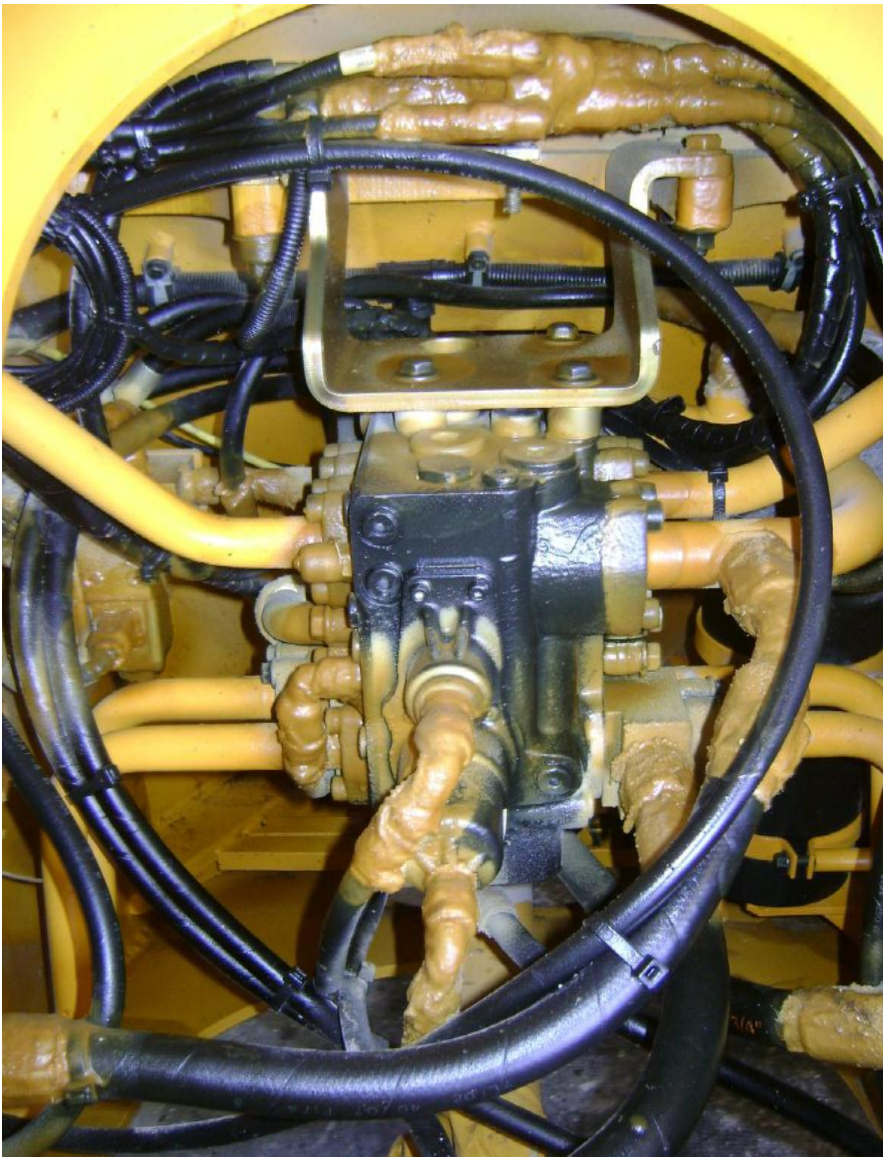
Figure 6: Loader treated for 2 years

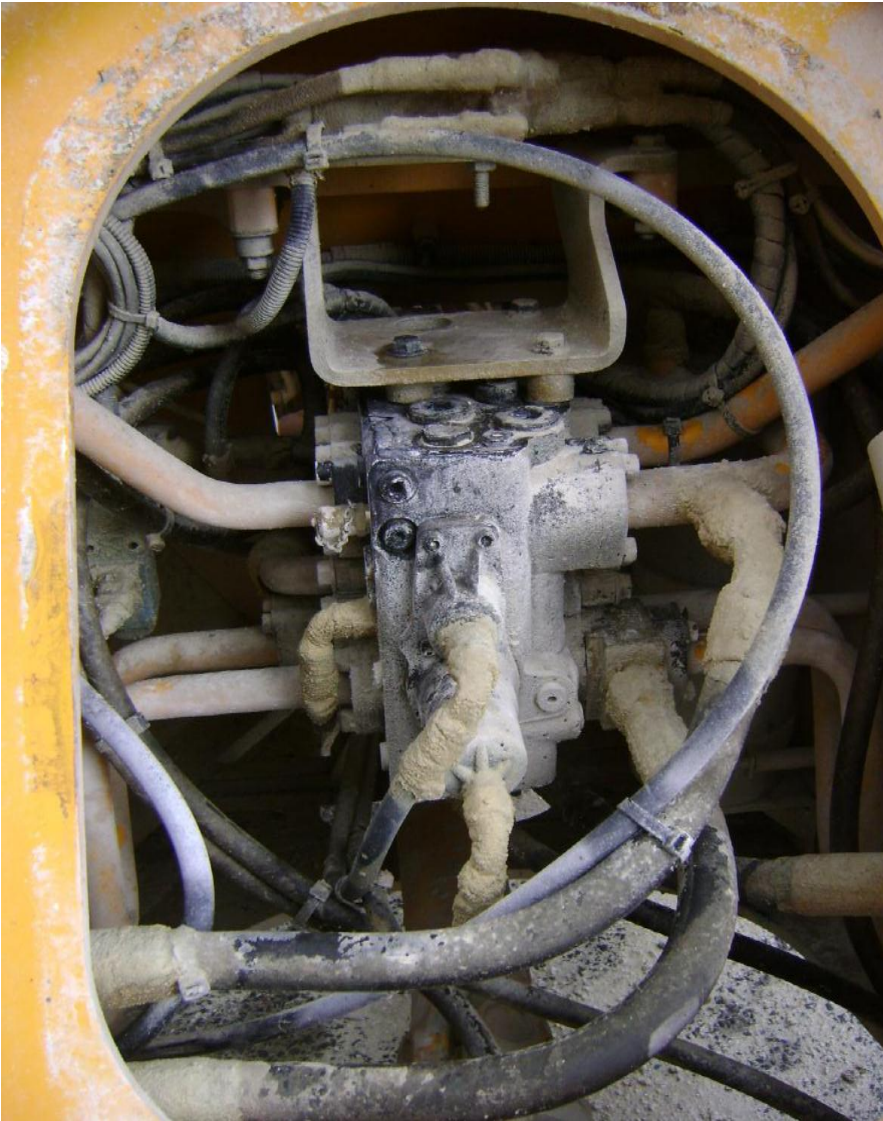
Figure 7: Loader washed cold water by operators each week 6

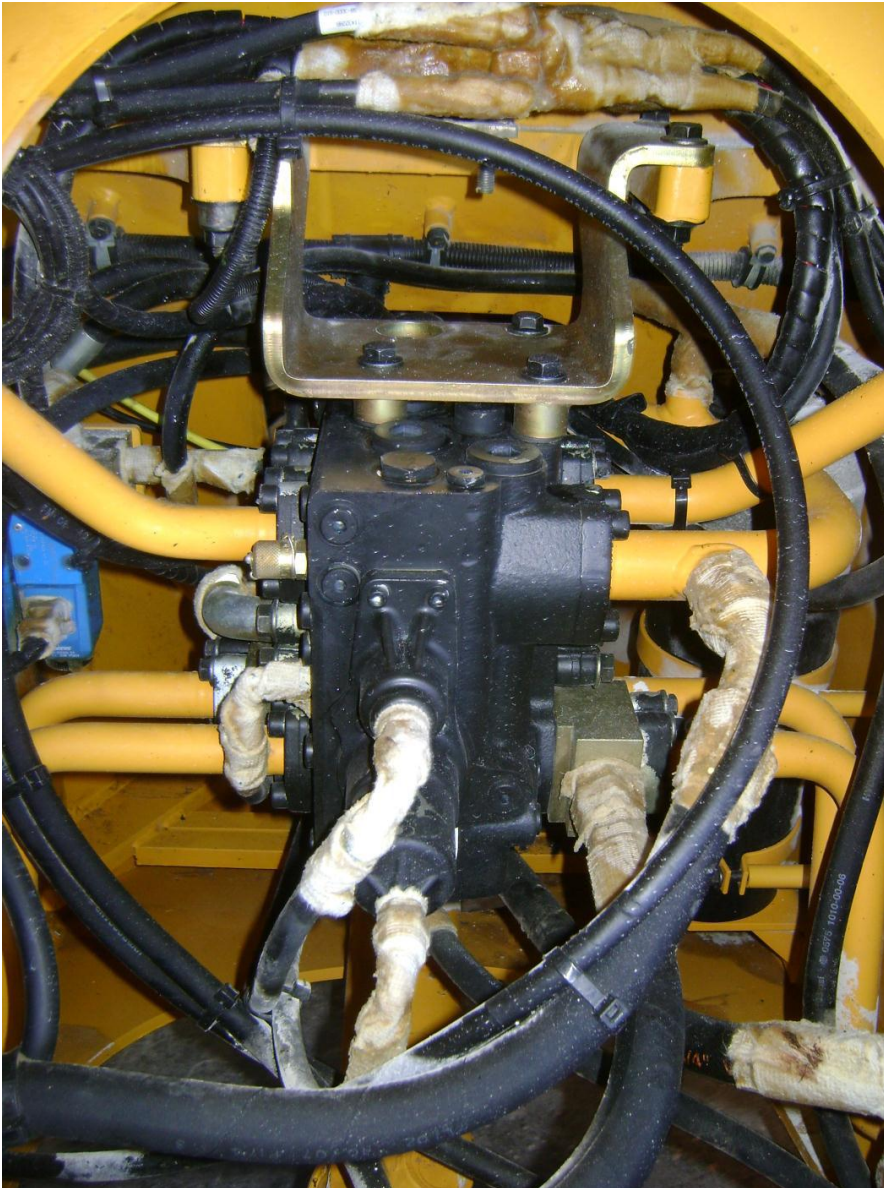
Figure 8: Loader washed hot water ready for treatment

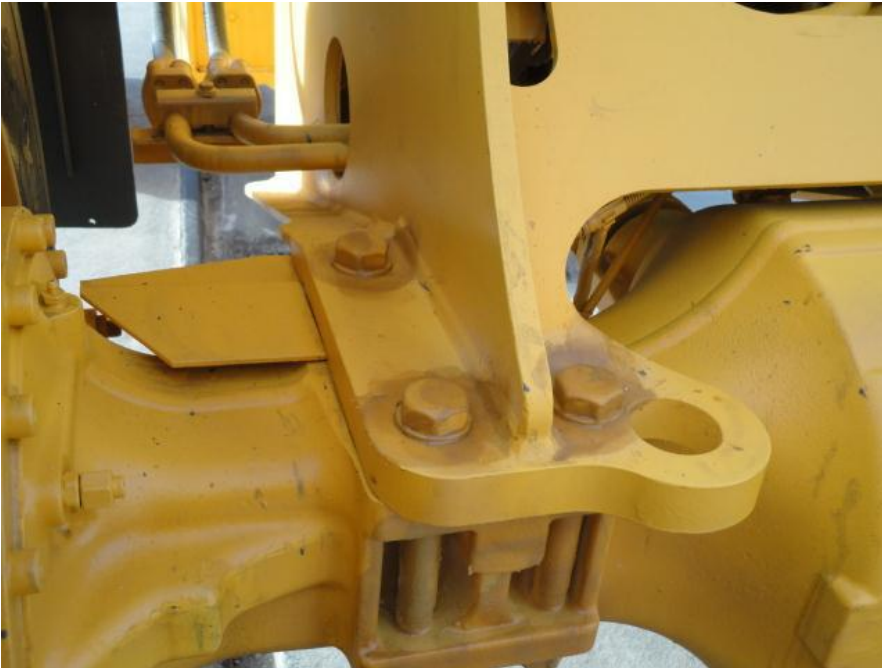
Figure 9: Front axle treated over 6 years

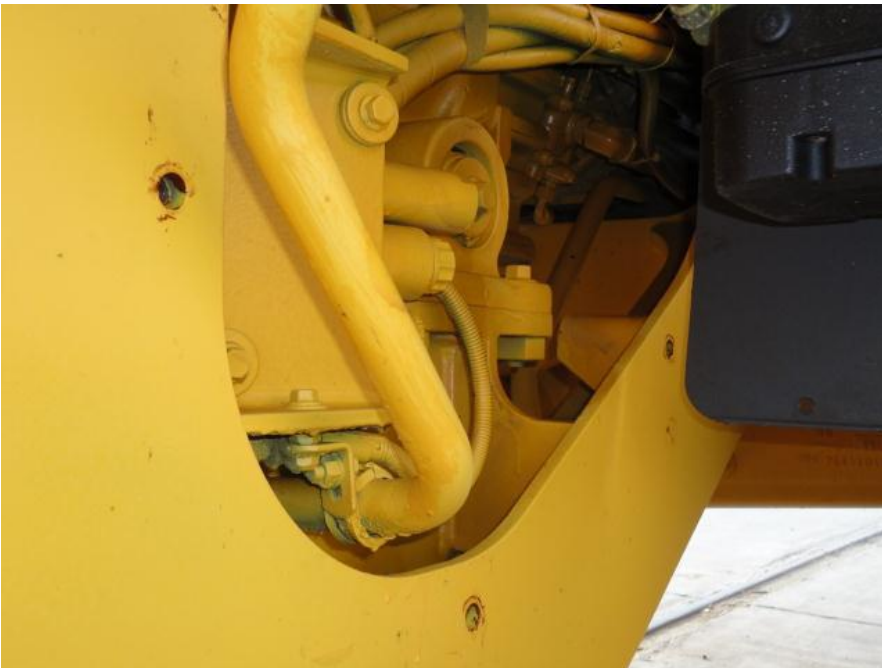
Figure 10: Side loader treated 6 years service

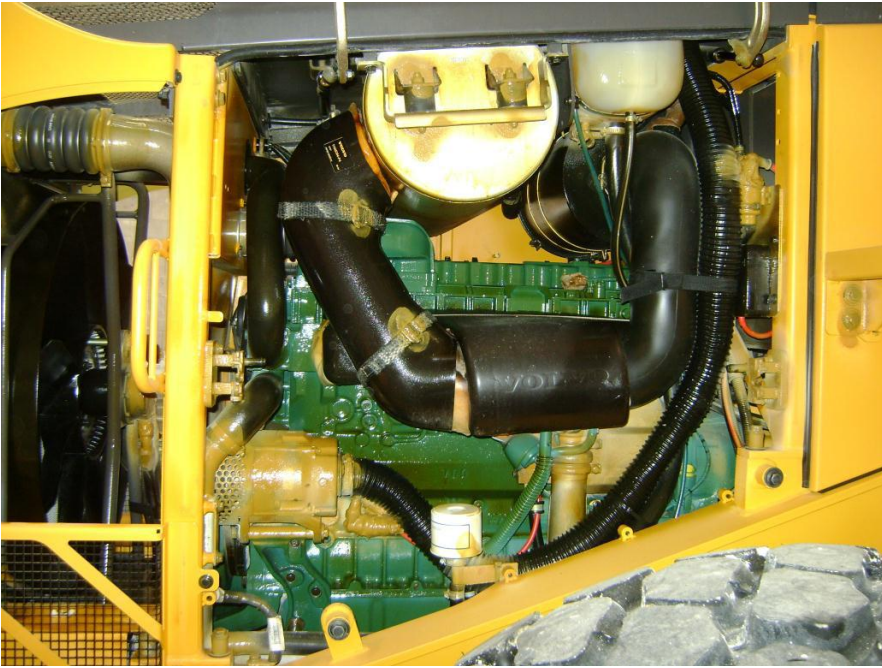
Figure 11: Loader treated 6 years - engine
